CARVER CORPORATION
SERVICE BULLETIN

Service Bulletin # M-2020-3

Model M-2020

Reason: To eliminate alternator induced noise in the M-2020.

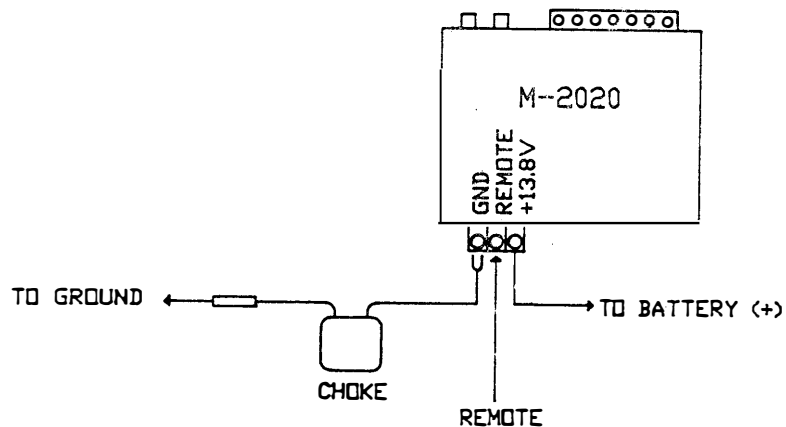
NORMAL CHOKE CONNECTION

THE OUTBOARD FILTER CHOKE IS PROVIDED TO ELIMINATE ALTERNATOR-INDUCED NOISE IN THE M-2020 AMPLIFIER. IT SHOULD NORMALLY BE INSTALLED IN SERIES WITH THE GROUND POWER CONNECTION, BUT SOME INSTALLATIONS MAY BE MORE EFFECTIVE IN SERIES WITH THE POWER (+) LEAD DEPENDING ON AGE AND MODEL OF CAR, TYPE OF INSTALLATION, WIRING SCHEME USED, ETC. THE CHOKE IS BI-DIRECTIONAL, I.E. IT DOESN'T HAVE A PREFERRED POSITIVE OR NEGATIVE LEAD. IT DOES NOT HAVE TO BE MOUNTED CLOSE TO THE AMPLIFIER. HOWEVER, THE ATTACHED SPADE LUG MAKES A CONVENIENT CONNECTION TO THE AMPLIFIER POWER TERMINAL BLOCK.

Procedure: Install Noise Filter Choke (P/N 601-00664-00) in series with the ground wire. See installation instructions.

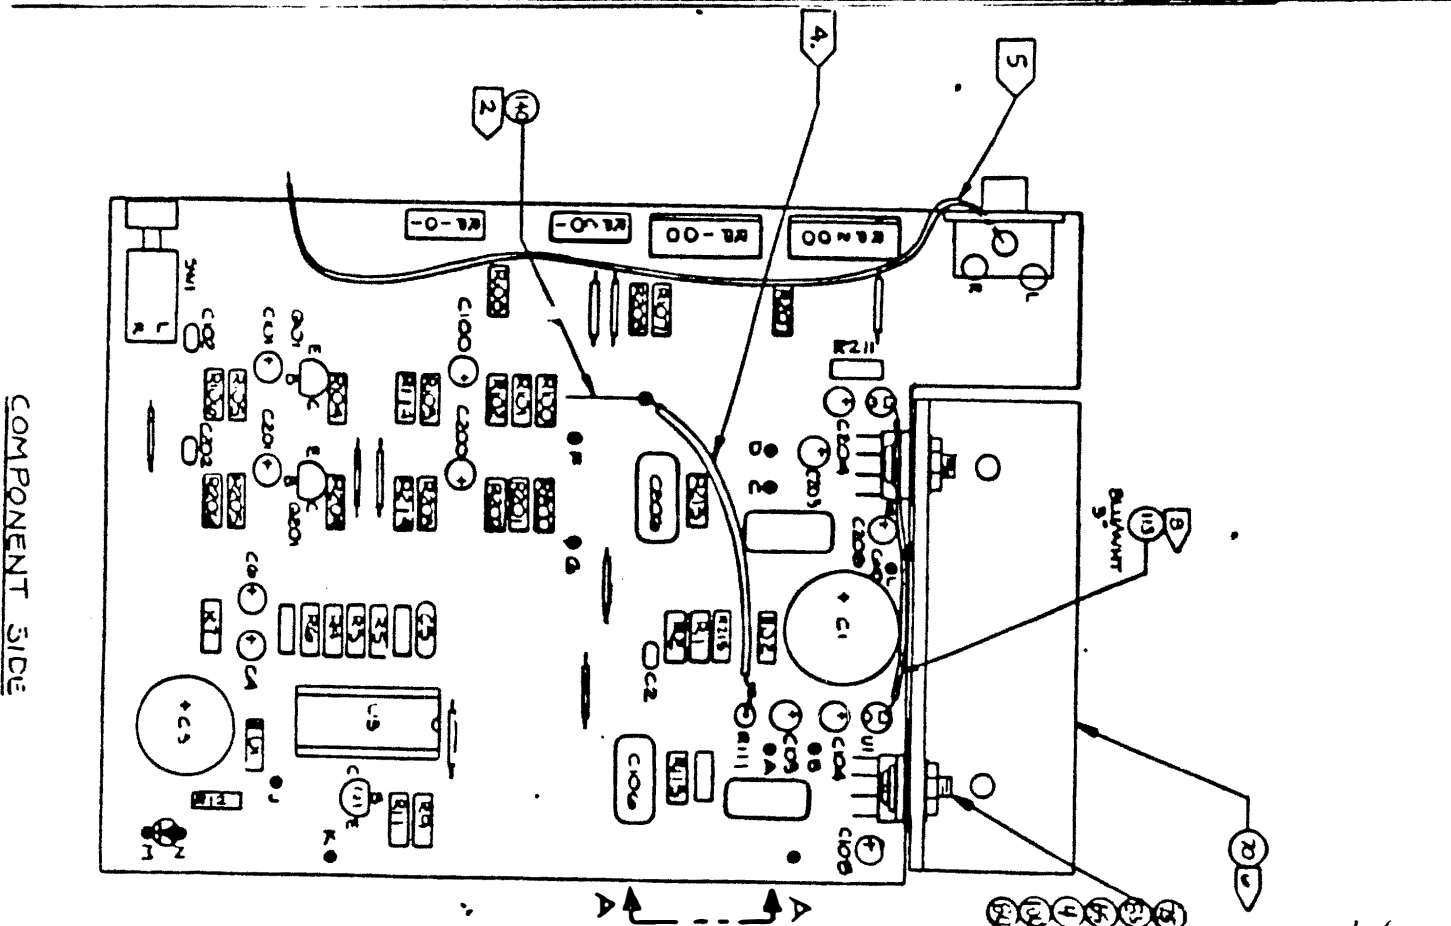
Reason: Turn off "pop" on the output.
THIS MUST BE DONE ON ALL UNITS.

Procedure: Remove jumper wire (Remove the jumper wire at location R215)
Add a 47 ohm resistor 1/4 watt where the jumper wire was removed.
Cut trace on the foil side of the board. (see page 2)
Add a three inch jumper wire to the component side of the board that goes from pin 2 of U1 to pin 2 of U2. (see below at note 113)
Remove C105 and C205 22uf 16v caps.
Add a 47uf 16v cap to the foil side of the board with the "-" side of the cap to ground and the "+" side to the other end of the 47 ohm resistor. Add sleeving to the leads of the cap. (see page 2)
